# Kymeta™ KyWay™ Terminal Troubleshooting Guide

Document number: 700-00020-000-rev04

08 June 2018

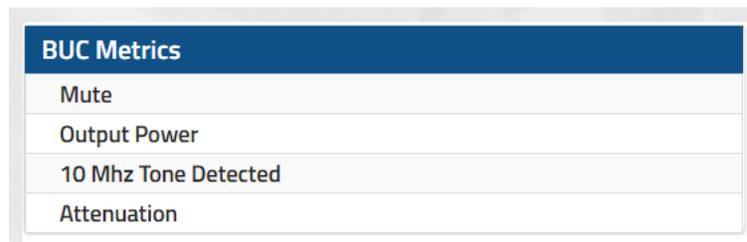
To check the status of the BUC in software version 1.1, in the web-based user interface, go **Pointing > Commissioning Mode** and check the the **BUC Metrics** status field. If the status field is blank as shown in the image below, then there is no BUC communication.

BUC Metrics
Mute
Output Power
10 Mhz Tone Detected
Attenuation

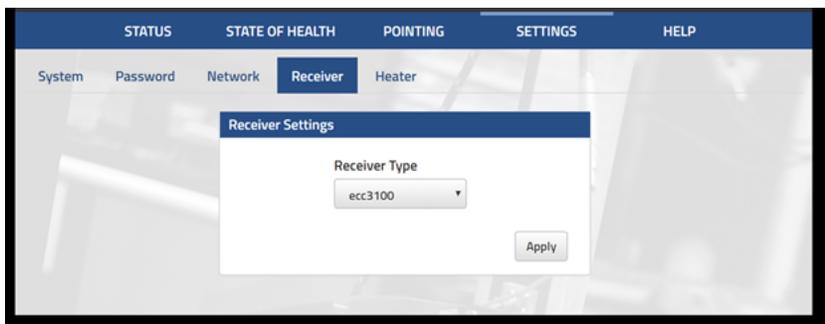
1. Verify that the tracking receiver is enabled. In the web-based user interface, go to the **Settings** page > **Receiver** window.

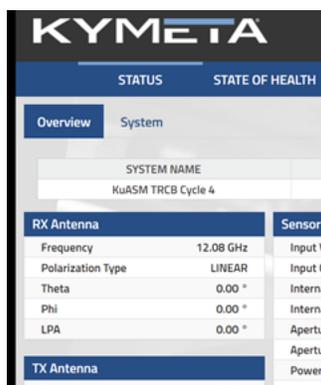
2. Verify that the receive frequency matches the expected downlink carriers. Go to the **Status** page > **Overview** window to check the receive frequency.

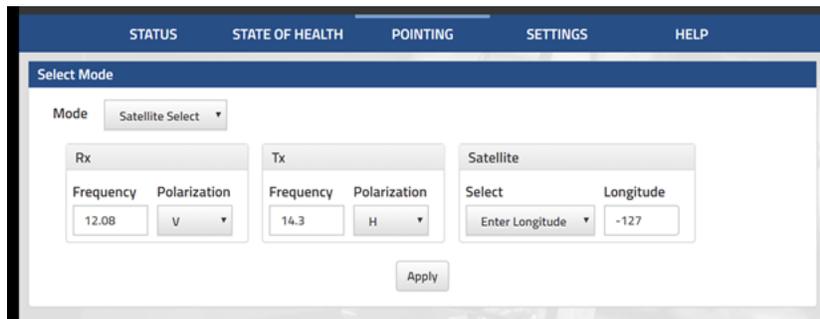
For a non-OpenAMIP terminal configuration, update the pointing mode to **Satellite Select** and provide the appropriate frequencies and satellite longitude.

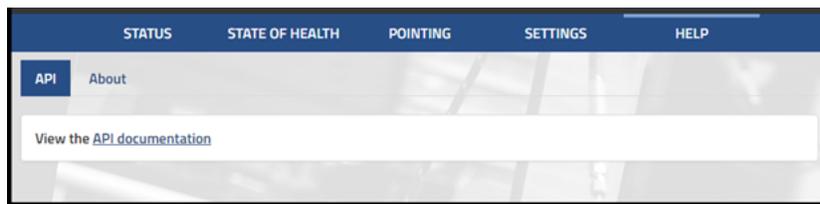
1. Open the tracking receiver API. Go to the **Help** page > **API** window. Click **API documentation**.

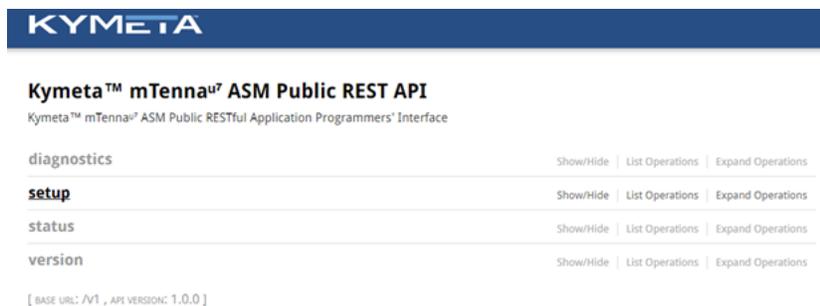
2. Click **setup** to expand the list of operations.
