## Technical Notification

Document number: 95-129256

### New software ver. 3.00 for EXPLORER® 500/300

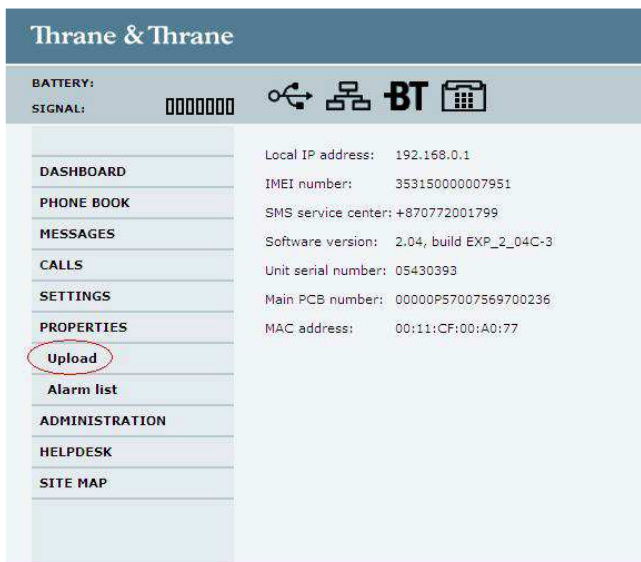
1. Make sure the EXPLORER terminal is switched on and connect the Ethernet cable to your PC.
2. Open your web-browser and open the Web Interface of the EXPLORER at address <http://192.168.0.1/>
3. Select 'Properties' and 'Upload'

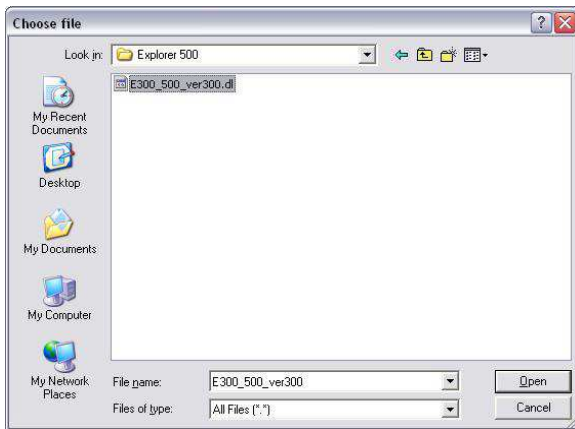
4. Select 'Browse' and locate the file 'E300\_500\_ver300.dl' and chose 'Open'.

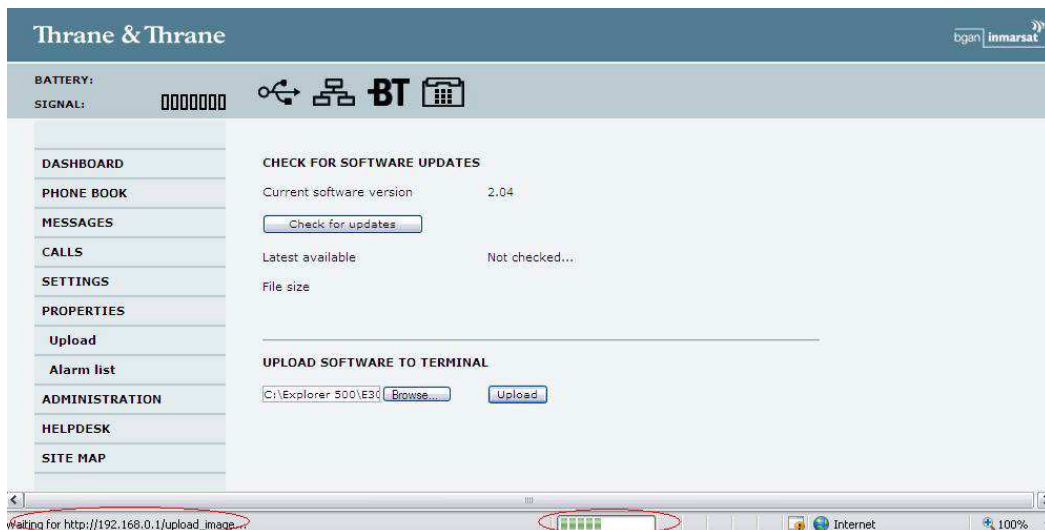
5. Choose 'Upload' and verify that the upload is in progress like below (status bar enabled in browser)
